The Safety of Tugboats in BC

BY ROBERT G. ALLAN, P.ENG, FSNAM, FRINA

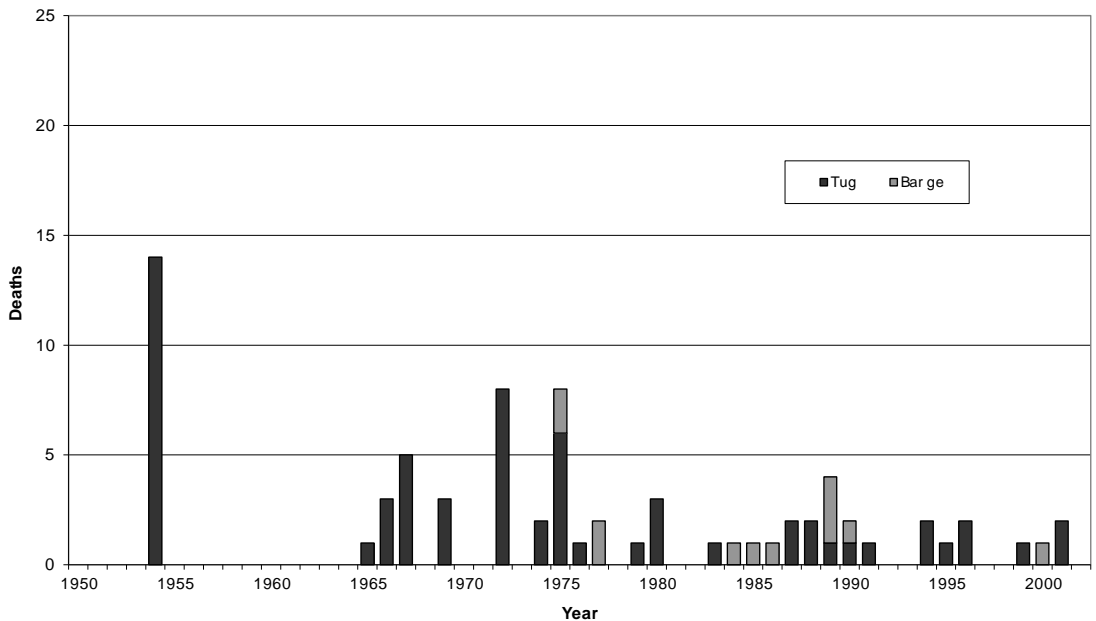
Fig. 1 Canadian West Coast Towing Industry Deaths, 1950-2002

towing industry deaths per annum between 1954 and 2002. If one removes from the data the calamitous loss of the tug CHELAN in 1954 then there is an average of about one death per year in the towing industry. The notable exceptions to this average were the losses of five crew each in the tugs GULF MASTER (1967), and HARO STRAITS (1972). One cannot be complacent about such statistics, but neither can one expect that such an industry can be entirely risk free, given the nature of towing operations throughout the coast, notwithstanding the normally high safety standards of the majority of tug operators.

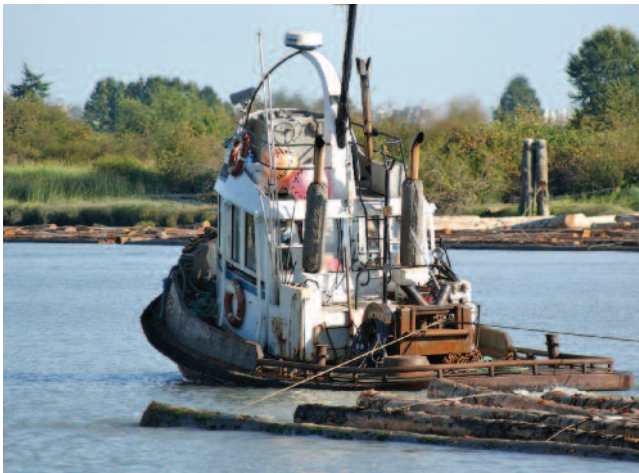
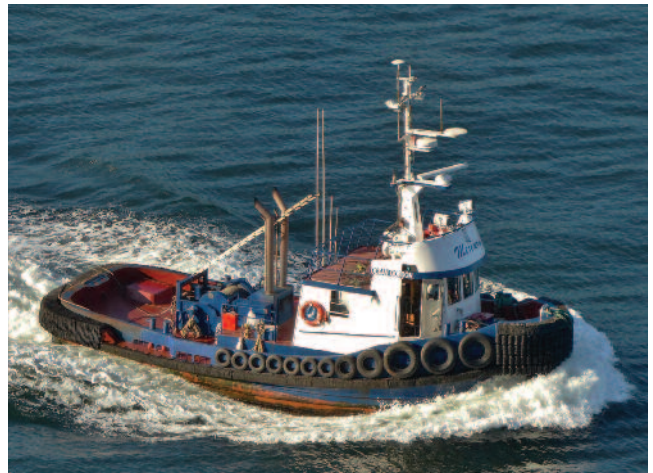
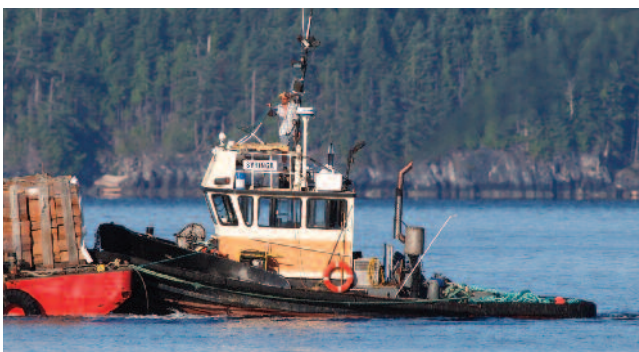
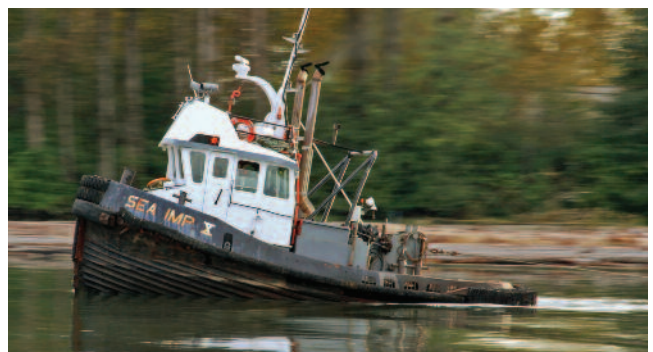
This “fiddle” of hull depth was the norm in tugs built before the tonnage measurement rules were changed (about 1997) where “phony” floors were installed to reduce the measured internal depth of the ship. Tonnage measurement surveyors allowed this subterfuge. The other common factor among these tugs is the distinct lack of freeboard, as evidenced by the photographs below:

In each case shown the minimum freeboard appears to be about 100–150 mm at best.

owners of existing under-tonnage tugboats to have a close look at their freeboard and associated stability characteristics, and restore their confidence that these boats are compliant with even the current minimal stability criteria of Transport Canada. ◀
